Historical-archaeological investigations at Akkerman (Bilhorod-Dnistrovsky) fortress, Ukraine, 2008

Caroline Finkel, Svitlana Bilyayeva and Victor Ostapchuk
Universities of Edinburgh & Exeter, Institute of Archaeology, National Academy of Sciences of Ukraine and University of Toronto

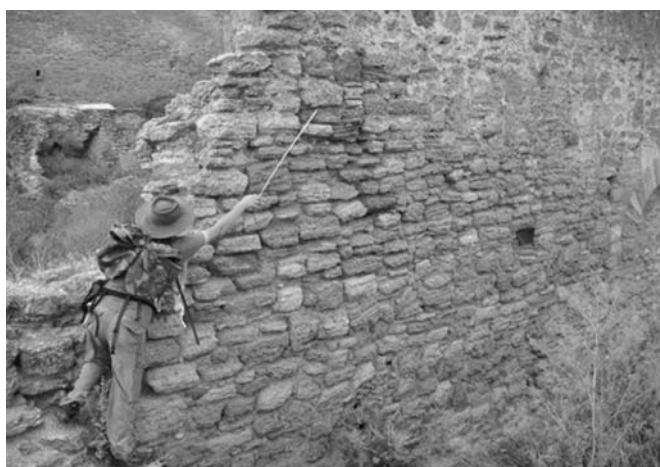
Julian Bennett pointing at a filled-in embrasure in the lower row of crenellations of the shore wall

We reported last year that the original plan and structure of the barbican and bathhouse were now known. The shore wall and barbican are seen to be an architectural whole, and, when first built, the wall was low – about 3.5m high – and topped with crenellations. Visible above this row of crenellations is a second row, and the wall is topped by musket loopholes that were built subsequently. The crenellations must date from a time before muskets were considered efficient enough to supplant bows and arrows. A document written soon after the siege of 1484 when the Ottomans captured the fortress from the Moldavians reports that the shore wall was low and must be raised. It is therefore possible that the lower row of crenellations is original, dating from the Moldavian period, and the second Ottoman, being the raised wall ordered after the siege. If further investigation proves this to be correct, then the barbican is also of Moldavian construction. As to the bathhouse, both material and documentary evidence continue to point to its construction in the late 15th century.

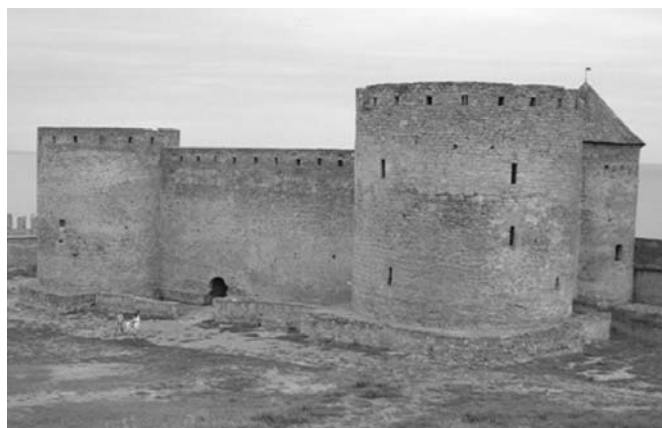
Rectangular bases of the southeast and southwest towers of the citadel

Close observation of the main structural elements of the fortress (combined with evidence from the Ottoman documents) allows for tentative revision of our previous understanding of its chronological development to suggest six major phases: (1) a donjon-type tower whose surviving 10m-high northwest wall was later incorporated into the northwest curtain of the 'Garrison Yard' immediately northeast of tower 25; (2) development with the plan and defensive arrangements, including the parateichion and deep ditch, that exist today, the citadel being planned (if not actually completed) with at least two rectangular corner towers, on the south side, their lower courses being embedded in the bases of the circular ones that now exist, and the outer circuit and parateichion provided with projecting square towers; (3) assuming the citadel was originally built with rectangular towers, the building of the present circular ones – otherwise the next major construction phase at the site is represented by the rebuilding of three of the square towers along the east side of the Garrison Yard to an octagonal plan; (4) next, almost all the square towers on the 'Civil Yard' curtain were rebuilt from foundation level to a polygonal plan in 'banded masonry', with alternating horizontal courses of

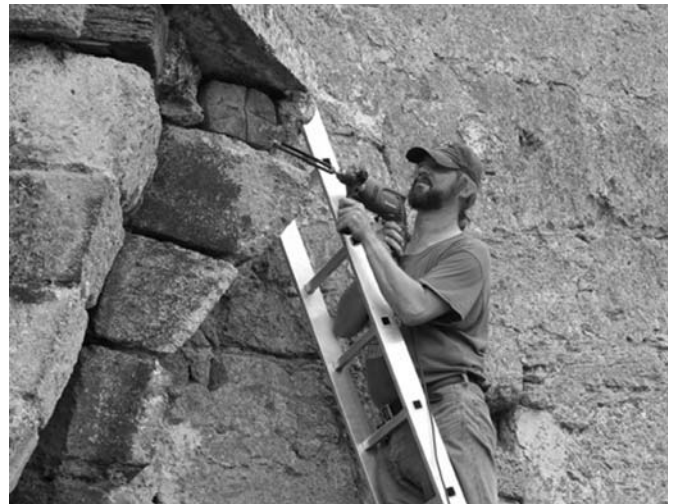
Tomasz Wazny extracting a wood sample from the bottom of the latrine chute on the shore side of the citadel under the northwest tower

Dendrochronology, based on tree-ring analysis of timber incorporated in built structures, can provide dating as reliable as the dated written record. Slices and cores were taken from 57 timbers at selected, accessible, points of the fortress. The majority proved to be oak, and Ottoman documents also indicate that oak was the wood most commonly used in construction works at Akkerman. A survey of existing tree-ring chronologies for oak in the wider region reveals that we can expect absolute dating from our samples. Chronologies exist for the upper Dnister (AD 890–1985), for Romania (Maramureş and Transylvania: AD 1410–1998), for southeastern Poland (AD 1100–1997) and the southern coast of the Black Sea (AD 1081–2004). Ottoman documents of the 18th century refer to Moldavia and Wallachia as the source of the oak used at Akkerman, and we eagerly wait to learn if this is borne out by the tree-ring analysis.
